Research article

Landslide potential in Cihanjuang, Cimanggung, Sumedang, West Java Province

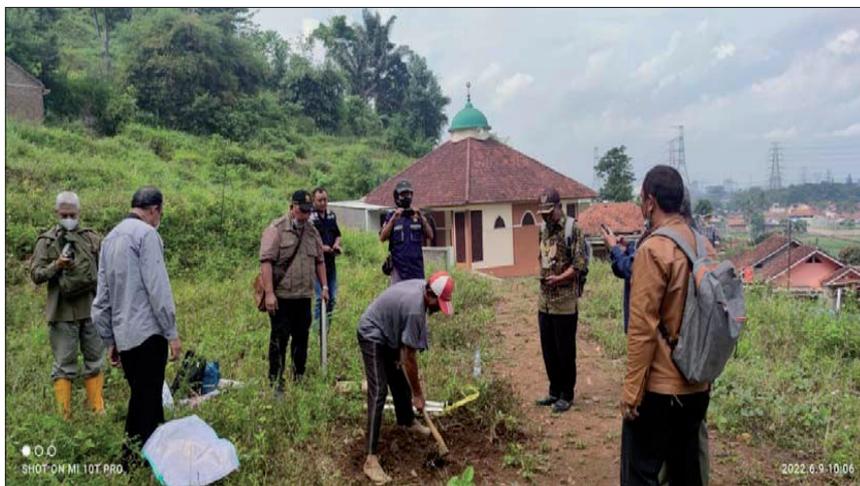
Figure 4. Disturbed soil sampling

For research, soil sampling and topographical mapping were carried out in this area. Soil sampling includes disturbed and undisturbed soil samples with depth 0.50 m – 1.50 m as shown in Figure 4 and Figure 5.
